# Recent Rehabilitation of Anacapa Island Lighthouse A Case Study

**A**nacapa Lighthouse is located on Anacapa Island, 11 miles off the coast of Port Hueneme, California. Built in 1932, it was the last lighthouse built by the U.S. Lighthouse Service. Until the 1995-1996 Coast Guard rehabilitation, Anacapa Lighthouse had never undergone any major repairs.

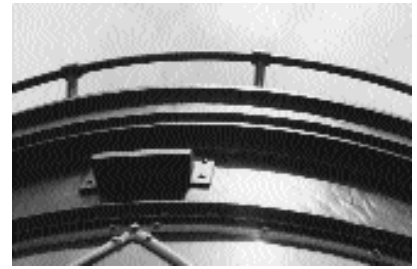
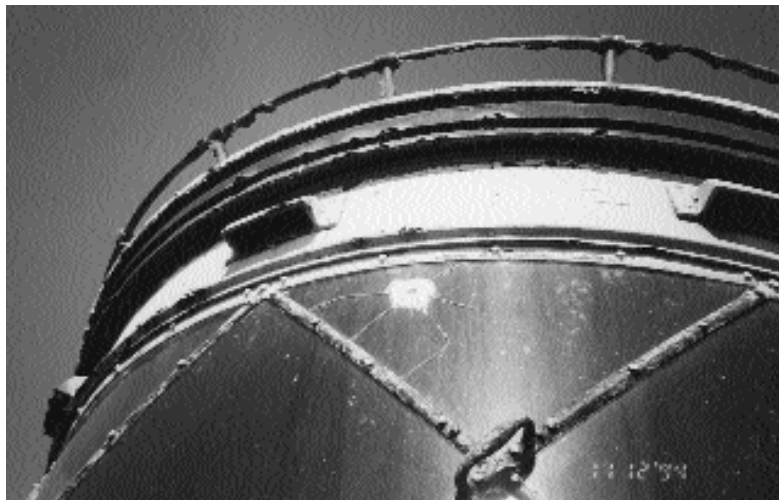
(Below and top right) Close-up of the deteriorated conditions of Anacapa Island Lighthouse before rehabilitation and finished metal work on the lantern after rehabilitation. Photos courtesy USCG.

- replace all broken lantern glass;
- replace the missing vent ball with a new fully functional replica cast 304 stainless steel (S/S) vent ball;
- replace the severely deteriorated ladder rails on the lantern room roof with 304 S/S replicas;
- restore the solid bronze lantern room door and lock to a fully operational condition;
- abate all lead and asbestos coatings;
- restore all vents to an operational condition;
- repair all decorative concrete details and structural concrete;
- replace all missing ventilation hoods and covers with historically-accurate replacement parts fabricated from 304 S/S;
- replace the severely deteriorated galvanized iron windows with new galvanized steel windows;
- install new coatings that require minimal maintenance by Coast Guard personnel.

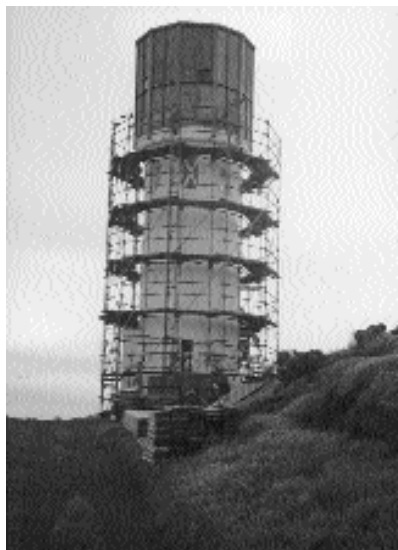
*The rehabilitation of Anacapa Island Lighthouse took place during the winter months, so no repair work could begin until the contractor completed an enclosure around the lighthouse. The enclosure served several purposes: containment of hazardous materials, protection of workers from severe weather, and a dry environment for the repair, prepping, and painting of the lighthouse. The first step in building the enclosure was the erecting of a scaffolding completely around the 30' concrete tower. Next was a weather-tight plywood enclosure for the cast-iron lanternhouse, complete with pitched roof to shed heavy rain. The final step was sealing the scaffolding in heavy shrink-wrap to provide weather protection and containment of any hazardous materials. The entire enclosure phase of the project took two weeks because of difficulties in handling the plywood and applying the shrink wrap in high winds. After the enclosure was complete, all deteriorated metal pieces that were scheduled to be replaced and did not require abrasive blasting were removed. Photos courtesy USCG.*

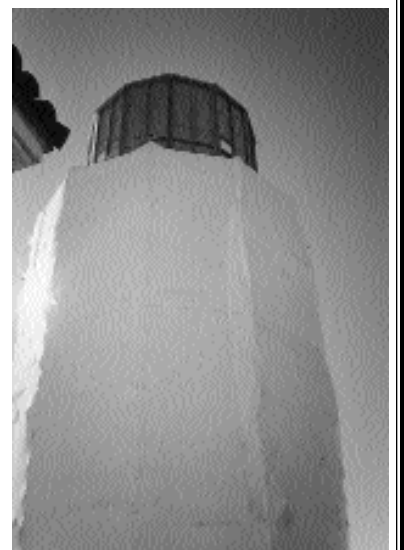
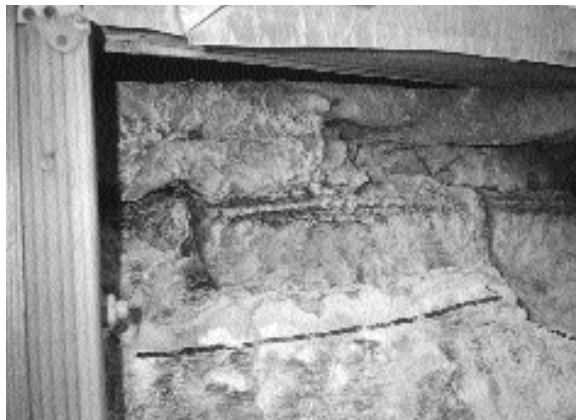
Close-up of the damaged concrete gallery deck after the loose concrete has been removed and before the damaged concrete was repaired using pressure-injected epoxy grout. The finished concrete repair is virtually invisible after the surface has been painted. Photos courtesy USCG.

One major area of concern was the concrete gallery deck located outside the lanternhouse. This deck had considerable damage in two areas without any evidence of the cause. The outer rebar showed signs of corrosion but the damage went 18 to 24 inches deeper into the concrete. Since freezing was not an issue, the cause of the damage was at first unknown. Closer examination revealed signs of an explosion inside the concrete, and we noticed bolt patterns for two old antenna mounts directly above the area. We determined lightning to be the cause. There was no practical way to dig out the broken concrete; the project was already over budget. We decided to do a pressurized epoxy injection and fill all the voids. The area was prepped and pumped full. The outer three inches were left unfilled so the two-part mortar patching compound could be used to restore the damaged area.

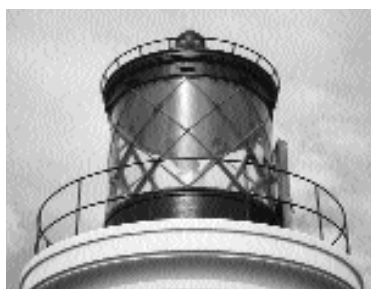
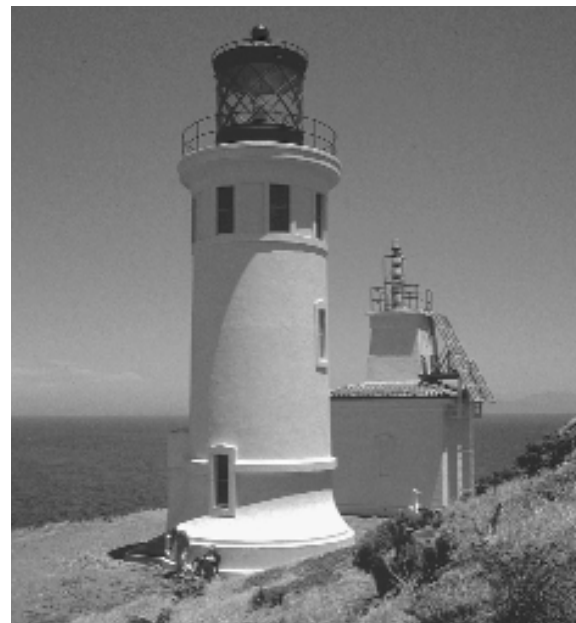
Views of finished lantern and overall shot of the rehabilitated lighthouse. Photos courtesy USCG and NPS.
